Subject: Inspection-Related Issues, Energy Fuels Resources, Energy Queen Mine and Exploration Project, M0370043, San Juan County, Utah

Inspection Report

Mine Name: Energy Queen (formerly Hecla Shaft)

Mine Name: Energy Queen Exploration
Operator Name: Energy Fuel Resources Corporation

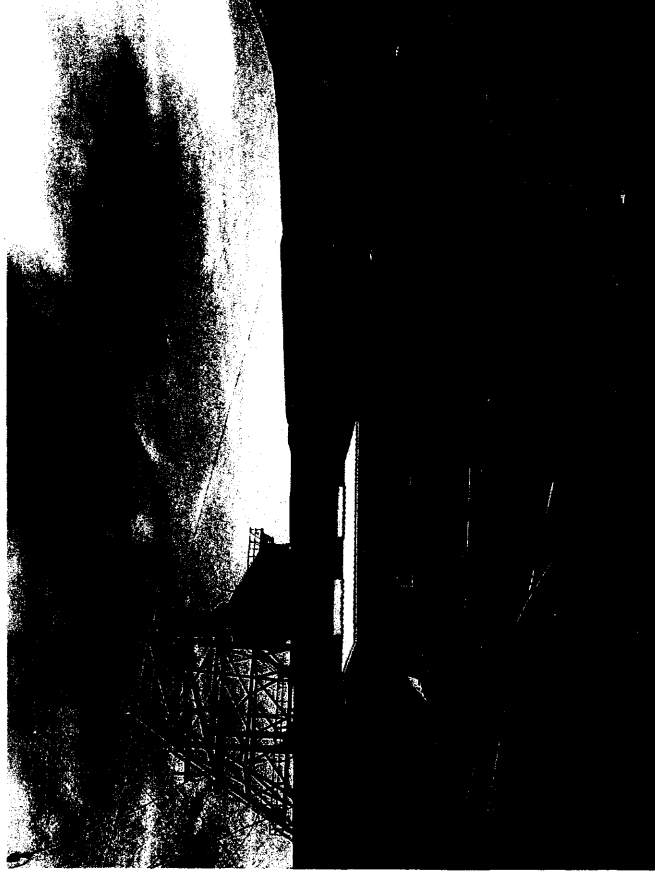
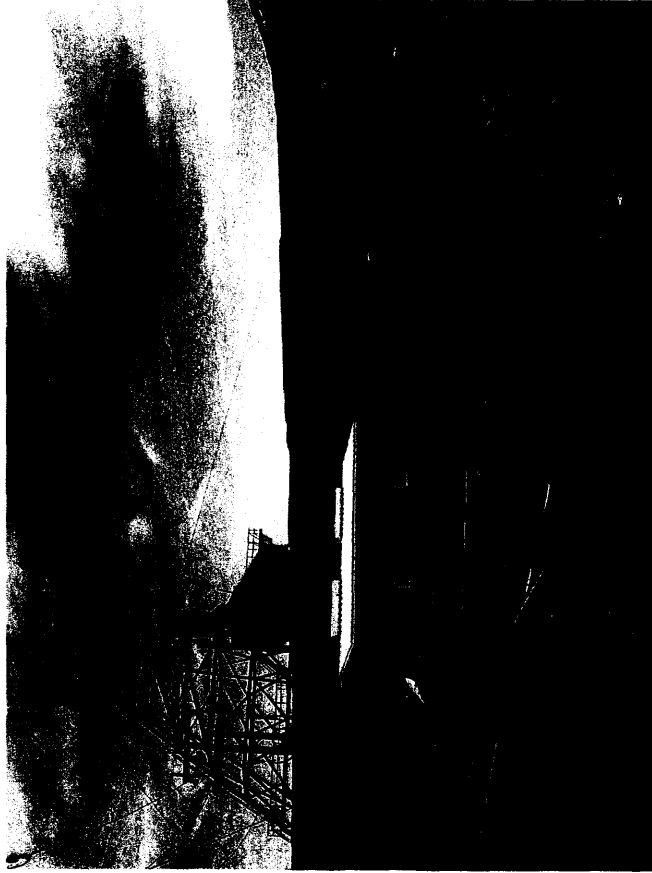
Some of the other facilities, including the main headframe and some fuel tanks, are shown in Photos 9 and 10.

Photo 9. An overview of part of the disturbed area.

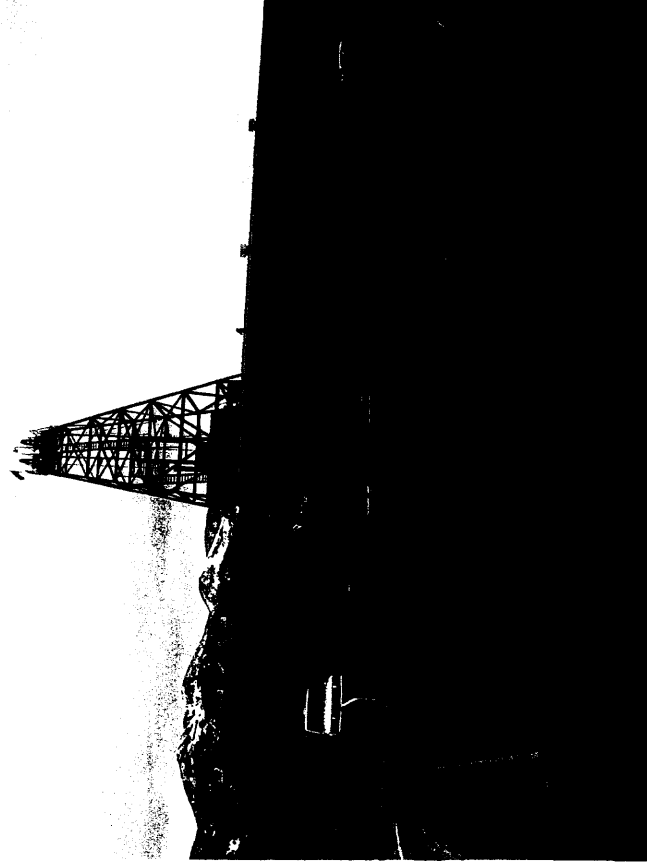
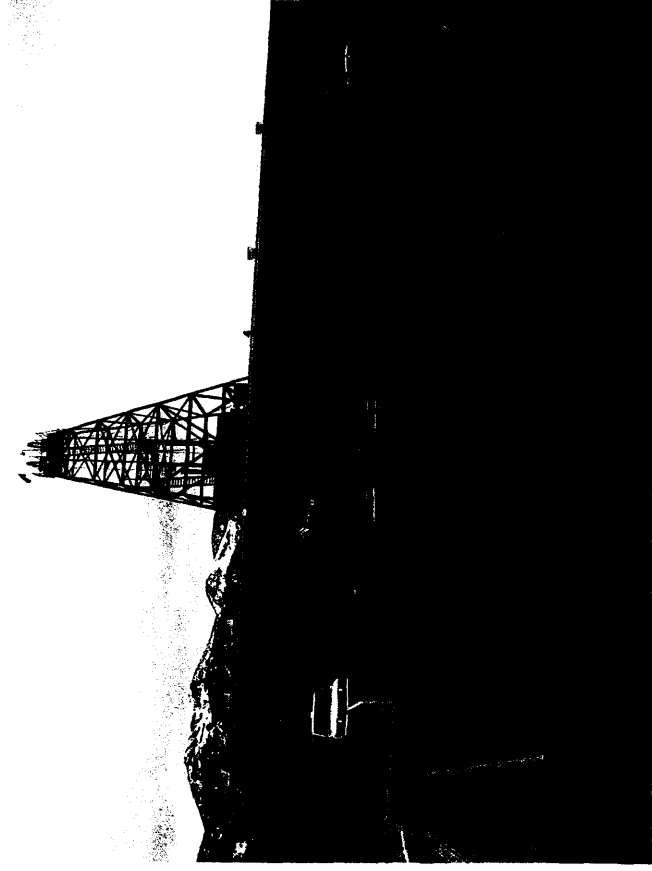
Photo 10. Another view of a portion of the disturbed area.
